# Constructed to Last

**Informed considerations for generational  
wastewater system construction**

## Executive Summary

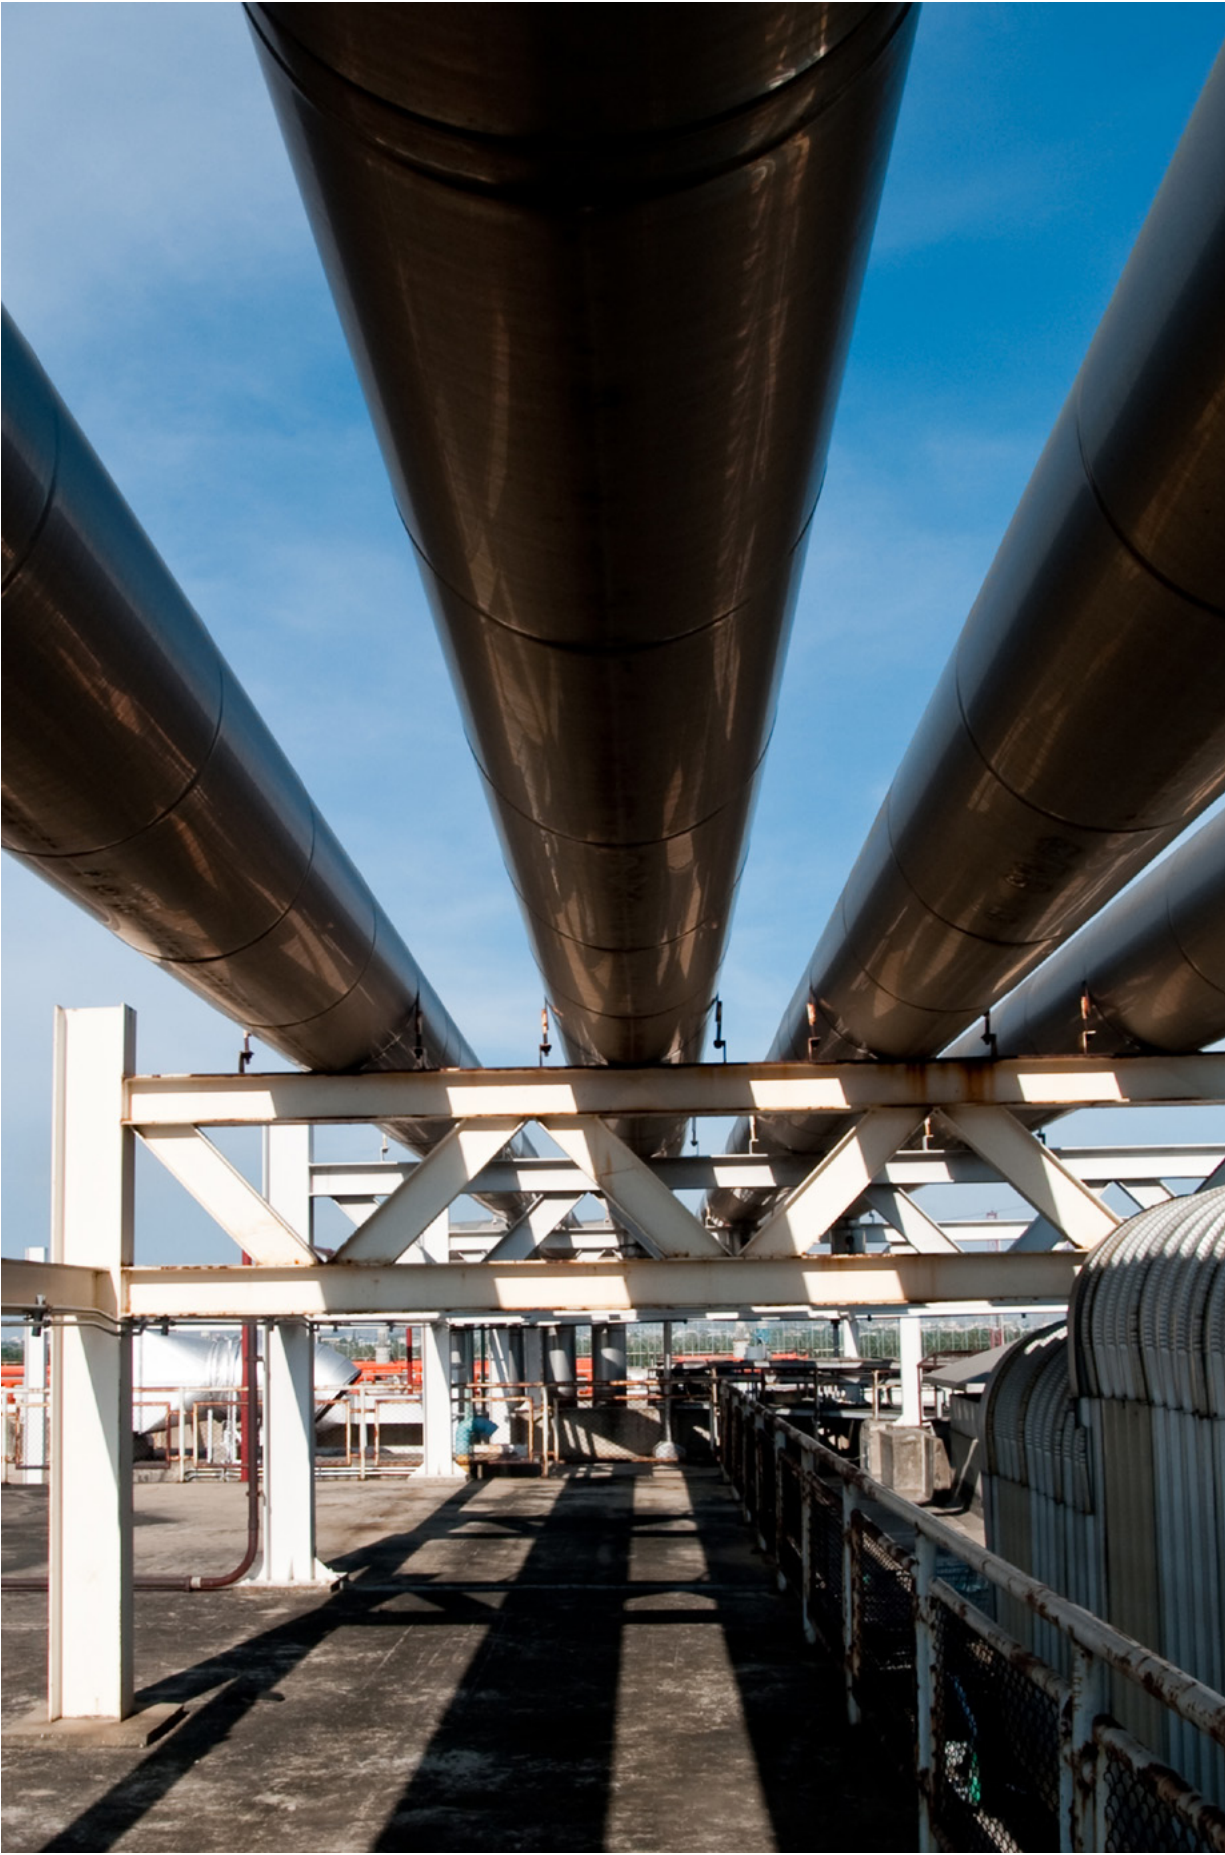
The Champion Strut system can be used as a Champion Duct conduit support system which is customizable with multiple channel profiles and parts to fit all types (GRC, PVC, etc.) of conduit installations. The system includes wall mounts, trapeze hanging systems and column loading supports for versatility in constructing conduit and piping support in projects.

Champion Strut is lightweight and can be easily cut and drilled to fit project specifications at the job site. Once installed, accessories such as pipe clamps, piping hangers and clevis hangers that hold and stabilize the conduit are inserted or attached to the strut channel. Contractors typically find that installation with Champion Strut moves swiftly and seamlessly.
